LAKE CHATUGE WATERSHED ACTION PLAN

March 2007

This document is intended to guide restoration efforts in the Lake Chatuge watershed in Towns County, GA and Clay County, NC for the purpose of returning it to good ecological health over the next 10-15 years. The Hiwassee River Watershed Coalition and Tennessee Valley Authority developed the plan cooperatively with input from citizens, community leaders, and local officials.

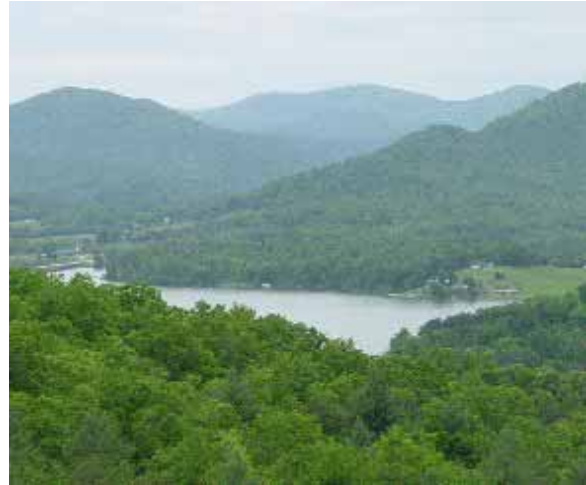
Figure 1. Overview of the Lake Chatuge Watershed Action Plan Area

Lake Chatuge is a 7,000-acre impoundment of the Hiwassee River located in the Blue Ridge Mountains of North Georgia and Western North Carolina (Figure 1). The reservoir straddles the border of the two states and the area of land draining to it lies wholly within Towns County, GA and Clay County, NC. An area of land that drains to a specific point, in this case Chatuge Dam is called a watershed. The Lake Chatuge watershed (outlined in red on Figure 1) is the land area for which this plan is written.

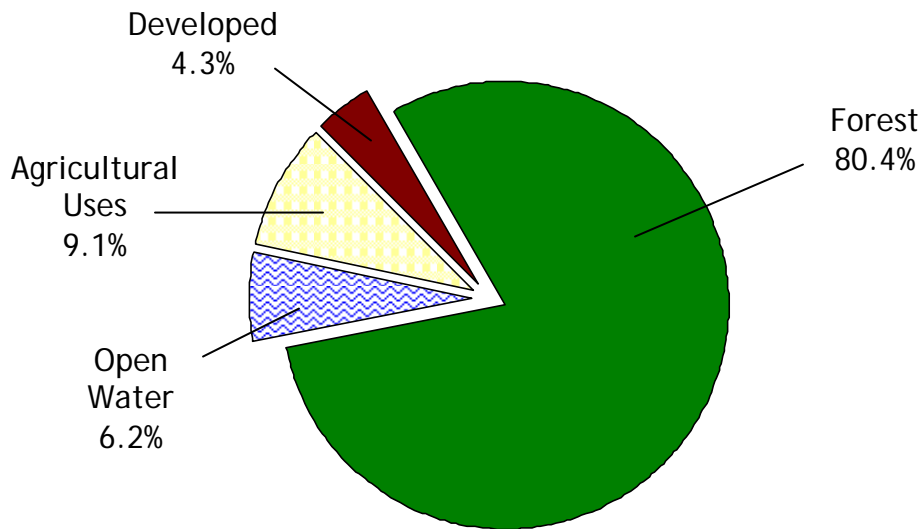
Figure 6. General Land Cover above Lake Chatuge Dam by Percentage (2002)

Lake Chatuge makes up about six percent of the drainage area above Chatuge Dam (Figure 6). The watershed is primarily forested (80.4%) and in 2002 there were still more than 10,000 acres (9.1%) of land in agricultural uses including pasture, cropland, and hay land. Developed land is increasing and, as of 2002, represented more than four percent of the drainage area (about 5,000 acres).
